## **F-111 Bonded Panel Repair Status**

DSTO-TR-0803

## ABSTRACT

A visit was made to Amberley Airbase between the 6th and 9th of September 1998 to consult with RAAF staff on current procedures and problems involved in the maintenance and repair of F-111 honeycomb panels. In conjunction with these discussions, a review of the current methods being used for honeycomb repair procedures was undertaken. The following report summarises the methods being used for repairs and the relevant reference documents. Also detailed are the major problems being encountered in these repairs and future problems which may arise as a result of the current status being maintained during the service life of the F-111.

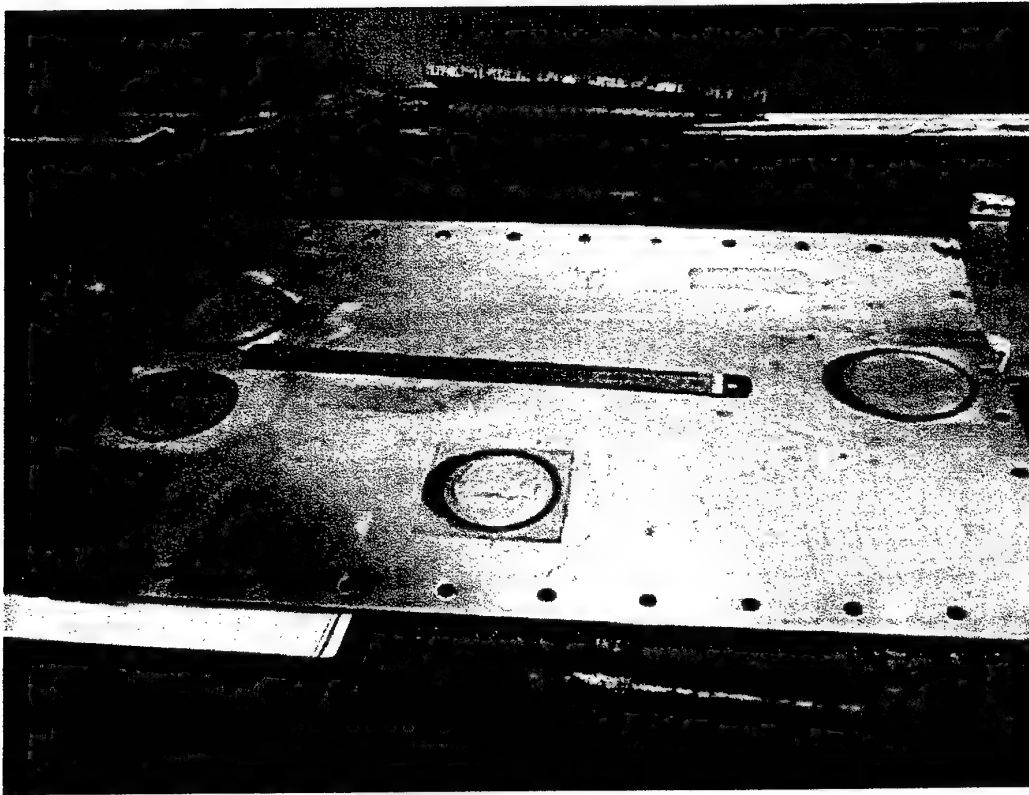
The first case in which this problem arises is when honeycomb panels with pre-existing injection repairs have a metal patch applied. The Engineering Standard C5033 indicates that a metal patch should be placed over existing injection repairs after NDI inspection and moisture removal. This procedure is conducted to provide environmental protection and structural strength to the honeycomb panel. Typically a tap test identifies the damaged region and skin is removed from this area. If the core is intact then moisture removal is undertaken and a patch is applied. In some instances further damage to the panel occurs during drying of the panel at 110°C. This damage is caused by steam pressurisation. Figures 1 and 2, however, provide a good example of the extent of the damage that occurs during the vacuum bag curing of the FM-300 adhesive when the structural metal patch is bonded.

*Figure 1.0 Structural metal patches bonded over injection repair areas of a honeycomb panel. Patches bonded at 160°C using FM-300. The ruler is 350mm long.*

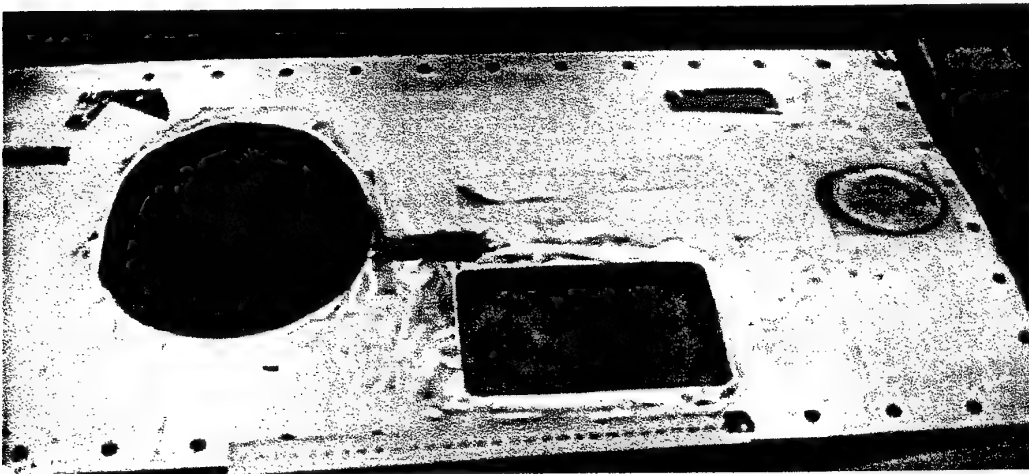
*Figure 2.0. The areas that had to be routed from the panel in Figure 1.0 as a result of disbond failure occurring during the cure cycle of the adhesive required for the patch application to the pre-existing injection repairs. The ruler is 350mm long.*

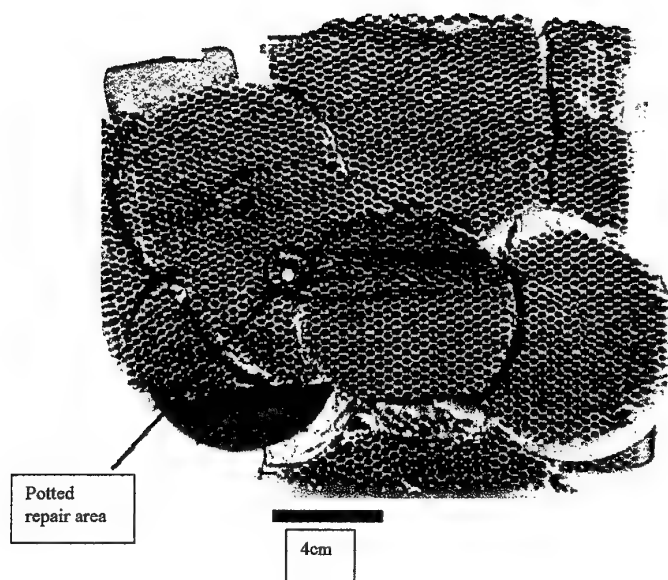
In the second example a potted repair was performed on an F-111 fuel tank. The initial repair involved riveting and potting a partially debonded patch as shown in figure 3. The damaged area was initially only 2cm in diameter. Subsequently, a series of holes were drilled for injection repairs to rebond the partially debonded patch, as shown in figure 4. A second patch to repair the rivet and potted repair in figure 3 was cut around the defective patch, thus reducing the required overlap length of the repair patch. The moisture removal procedure, refer section 4, extended the damage, leading to a full skin and core removal of approximately 25cm x 25cm. The repair shown is in figure 5. The repair requires a request for disposition/request for waiver(RFD/RFW).

Figure 3.0 The initial repair of an F-111 fuel tank. This involved riveting and potting a partially debonded patch. This area was initially only 2cm in diameter.

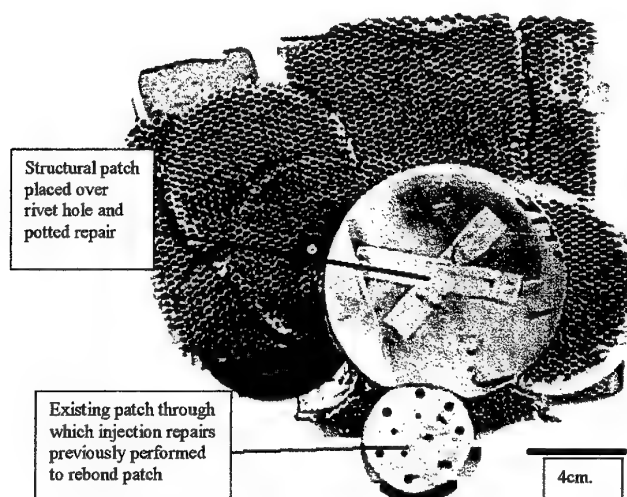
Figure 4.0 The second stage of the F-111 fuel tank repair. Injection repairs attempted to rebond the partially debonded patch. A second patch to repair the rivet and potted repair in Figure 3 was cut to fit around the defective patch, reducing the required overlap specified by the repair document.

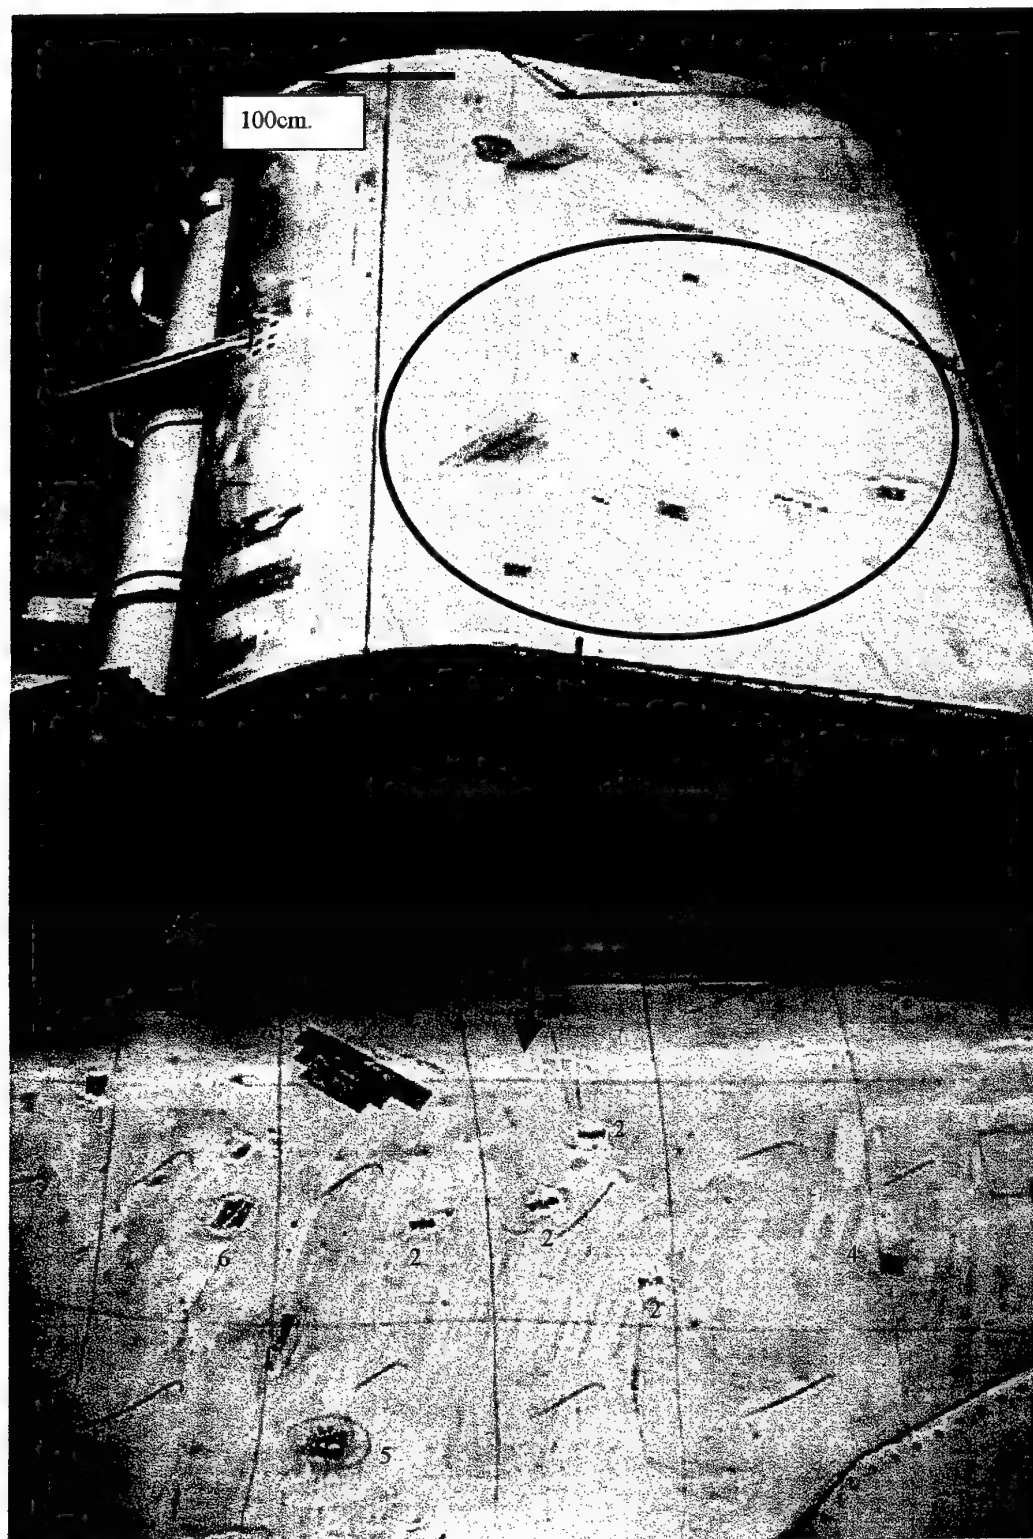
Figure 7.0 An example of the potential number of injection repairs, which may be associated with one F-111 honeycomb bonded component. Injection repair hole numbers are indicated. None of these repairs had been protected with a structural patch.

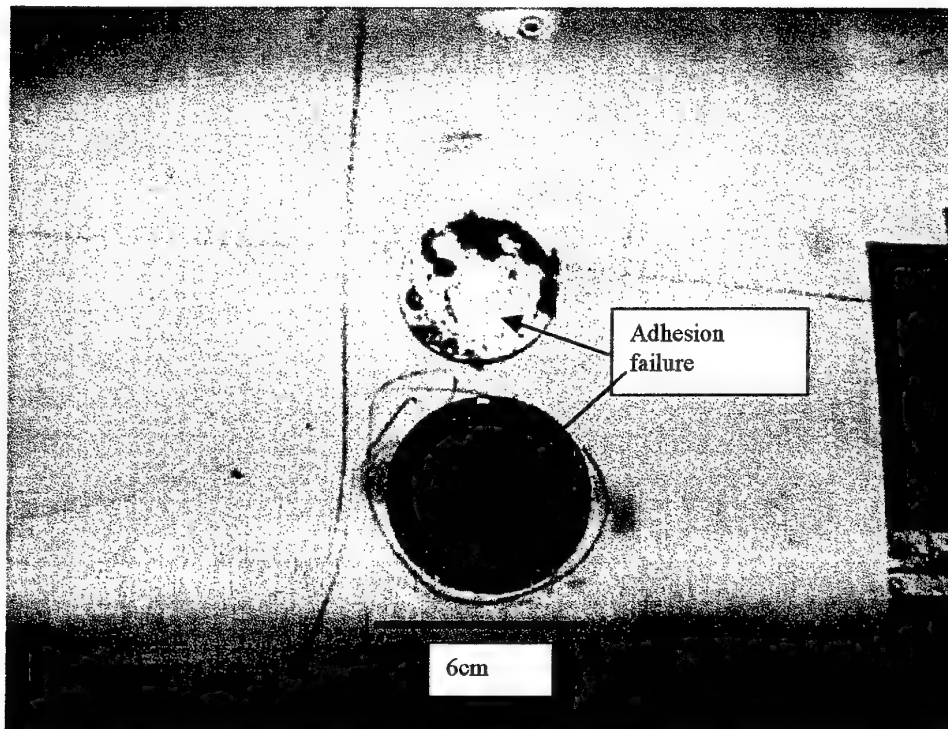
Figure 8.0 Adhesion failure surrounding an injection repair

regions around an injection repair have experienced obvious environmental degradation. In Figure 8 adhesion failure between the core and skin has occurred around an injection repair. In Figure 9.0 the adhesive-core fillet bonds have failed over an extensive area around the injection repair site as a result of penetration of water through the injection repair between the adhesive and core bond.

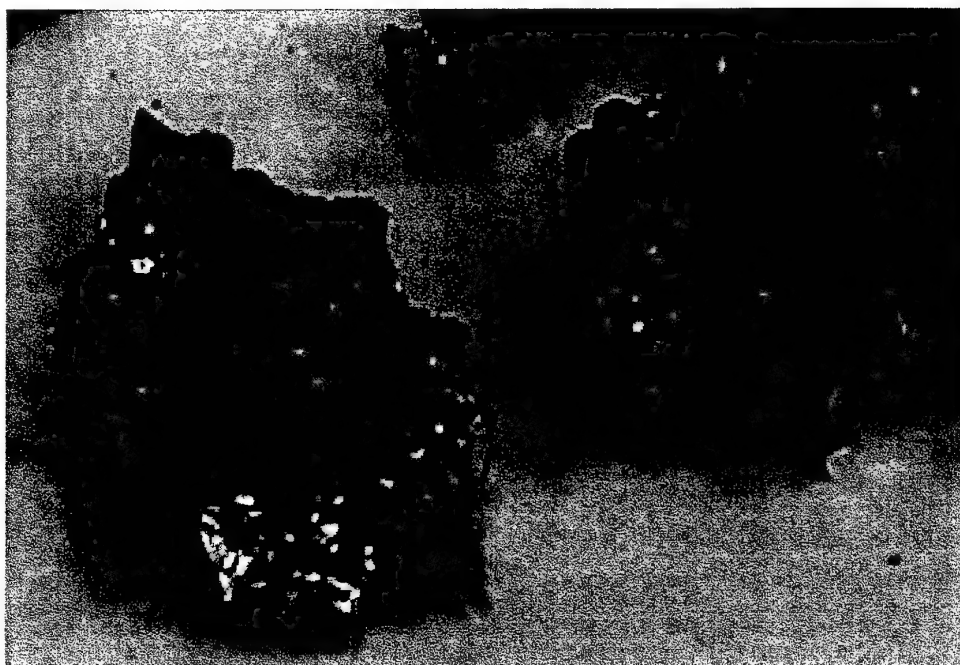
The examples provided in Figures 1.0 to 6.0 indicate the problems associated with current methods where patches are placed over injection repairs. The injection repairs may have been exposed to high humidity for up to 20 years and the resultant moisture uptake of the honeycomb panel may be significant. Figure 12 indicates two pieces of honeycomb that had been injection repaired. The ability to remove moisture from this region of the repair and surrounding areas is clearly very difficult. The vacuum heating will be unable to remove moisture from the dense potted adhesive. Similarly, the potted adhesive will act as a barrier for the removal of moisture from surrounding areas.

Figure 12 Two pieces of honeycomb core material that had previously received an injection or potted repair.

1) One of the potential solutions offered to this problem is to use room temperature curing adhesives instead of the high temperature curing structural adhesives that are currently used for the environmental patch application. It is believed that this will prevent steam evolution during cure and minimise the extent of disbond damage. There are potential difficulties inherent with this solution. Initially, the current NDI is inadequate to identify the real extent of the honeycomb degradation around an injection repair, as indicated in Figures 8.0 and 9.0. Hence, a room temperature cure patch may be applied over a structurally defective area. Secondly, the room temperature cured adhesive may not be rated for the repair location. Thirdly, the current C5033 Engineering Standard surface preparation procedure, refer Table 2.0, requires heating the honeycomb panel above 100°C to dry the panel after surface preparation. These conditions are sufficient to cause disbonding of the panel as a result of internal pressures generated by steam production. Finally, if a repair such as a honeycomb core replacement is then required in the vicinity of a panel with these room temperature adhesive patches, then the potential for larger disbonds to occur will result, as exemplified in Figure 6.0.

2) A second solution to this problem is to place panels in a moisture free 50°C storage environment prior to repair. Currently it is not clear to what extent moisture can be successfully removed from moisture laden honeycomb panels or the time frame required to remove enough moisture from the panel to prevent the disbonding problem.

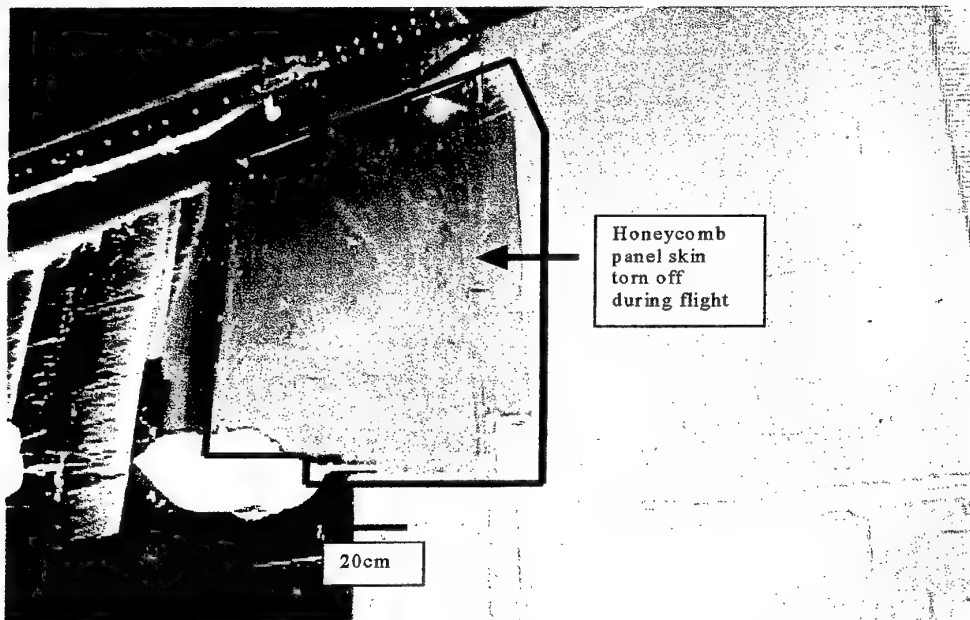
*Figure 13 The exterior skin of a honeycomb panel that was removed during flight. The scale marker indicates the size of the panel. The location is just forward of the engine air-intake.*

Here, the exterior skin from a large honeycomb panel was torn off the aircraft during flight just forward of the engine intake. Whilst it is unlikely that the skin would have entered the engine it would not have been impossible for some parts of the panel to have been sucked through the air-intake and cause significant engine damage. Clearly, not dealing with the problems of honeycomb panel structural integrity has the potential to lead to serious damage to the aircraft structure during flight and in a worse case scenario to loss of the aircraft.

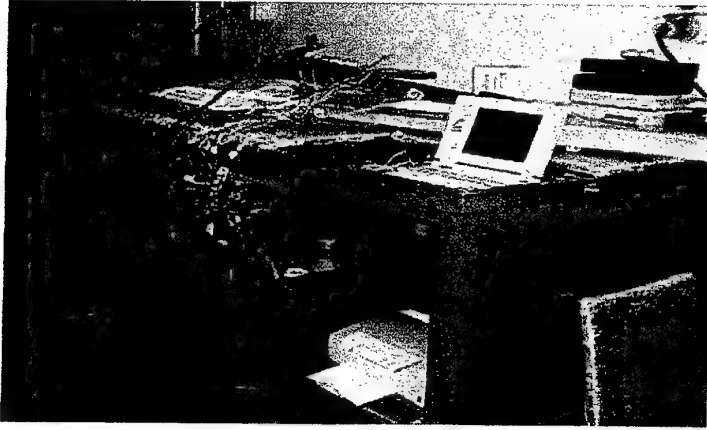
*Figure A-2 Moisture evacuation of the repair area using the vacuum bag, heater blanket arrangement, using a hot-bonder unit HBC-43 from Novatech®.*

The routed area then has a moisture evacuation performed at 85°C and -75kPa with 6 thermocouples and a heater blanket either side of the repair area, refer figure A-2.0.

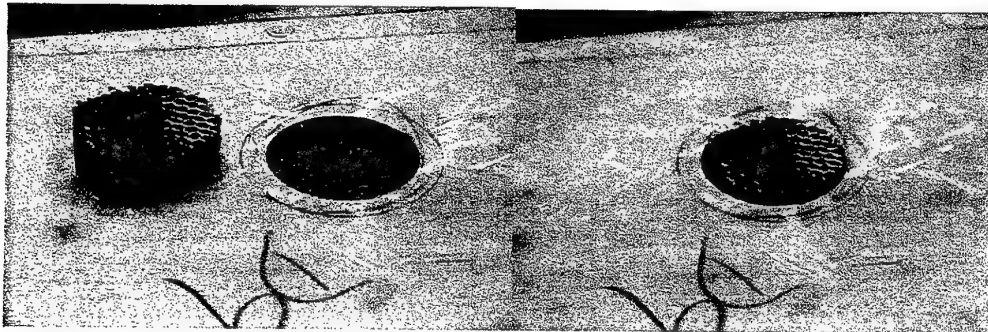
*Figure A-3 The core plug insert used to repair the routed core*

Before moisture evacuation a piece of honeycomb plug is carefully cut to shape which is 10mm thicker than the skin level, as indicated in figure A-3.0.

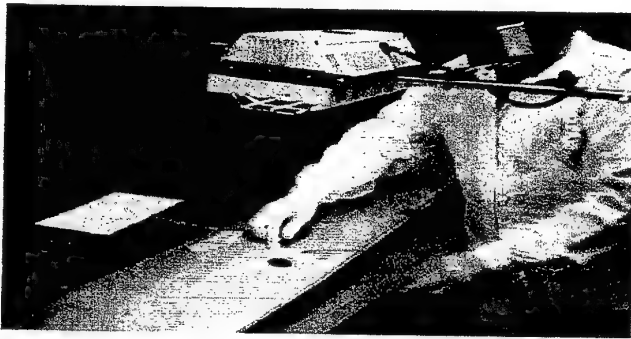
Figure A-4 Infrared heating of core after MEK flush.

The core plug is then flushed with methyl ethyl ketone (MEK), analytical reagent and dried at 110°C for 2 hours using an oven. The routed area of core on the panel is also flushed with MEK and an infrared lamp is used to dry the repair area at 110°C for 2 hours.

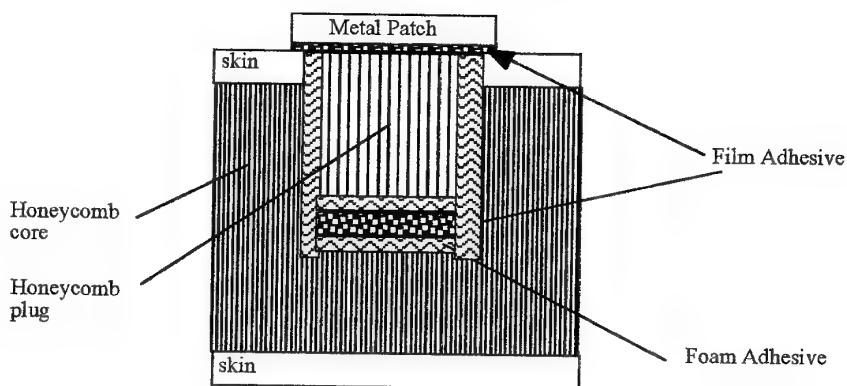
Figure A-5 Diagram indicating the details of the plug adhesion process. Step 1 involves curing the plug in place. Step 2 involves application of the metallic patch.

After the drying of the plug insert, pre-thawed foaming and film adhesive are cut to shape and applied to the plug insert as shown in figure A-5.0. Once the core area on the panel is dried, the plug and adhesive are applied to the routed core area. The plug insert is cured initially, as shown in figure A-6.0, and the metallic patch is applied as the final step of the repair, figure A-7.0.

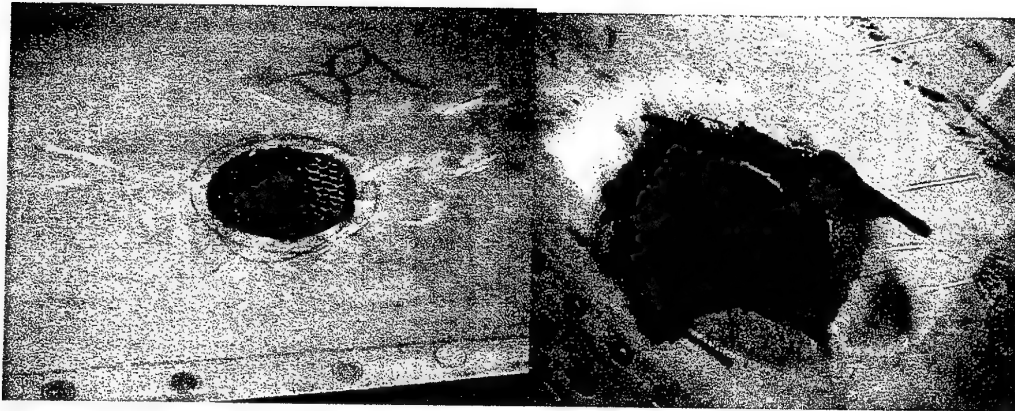
*Figure A-6 The two pictures indicate that the plug bonded in position after the initial adhesive curing step. Note in the left-hand picture the foaming adhesive has not expanded correctly and voids exist between the plug and routed core. In the right hand side picture the foaming adhesive has expanded correctly. The foaming adhesive came from the same batch.*

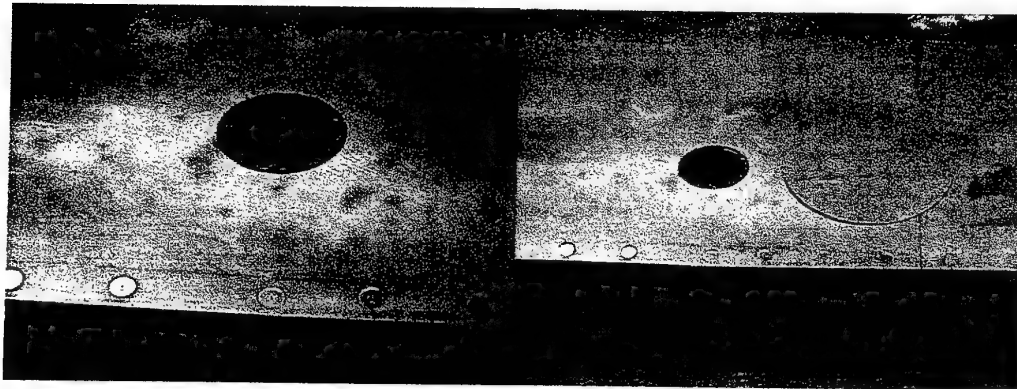
*Figure A-7 The plug is sanded back to flush with the skin level and a metallic patch is applied using FM-300 film adhesive.*

The skin surface and metallic patch are pre-treated with the standard grit-blast silane process and dried at 110°C for two hours. FM-300 film adhesive is then cured at 160°C for 1 and ¾ hours using the standard vacuum bag procedure.
